## **HOSPITAL FIRE**

St. Jerome, Quebec Canada

January 29, 1989

**Summary Investigation Report**

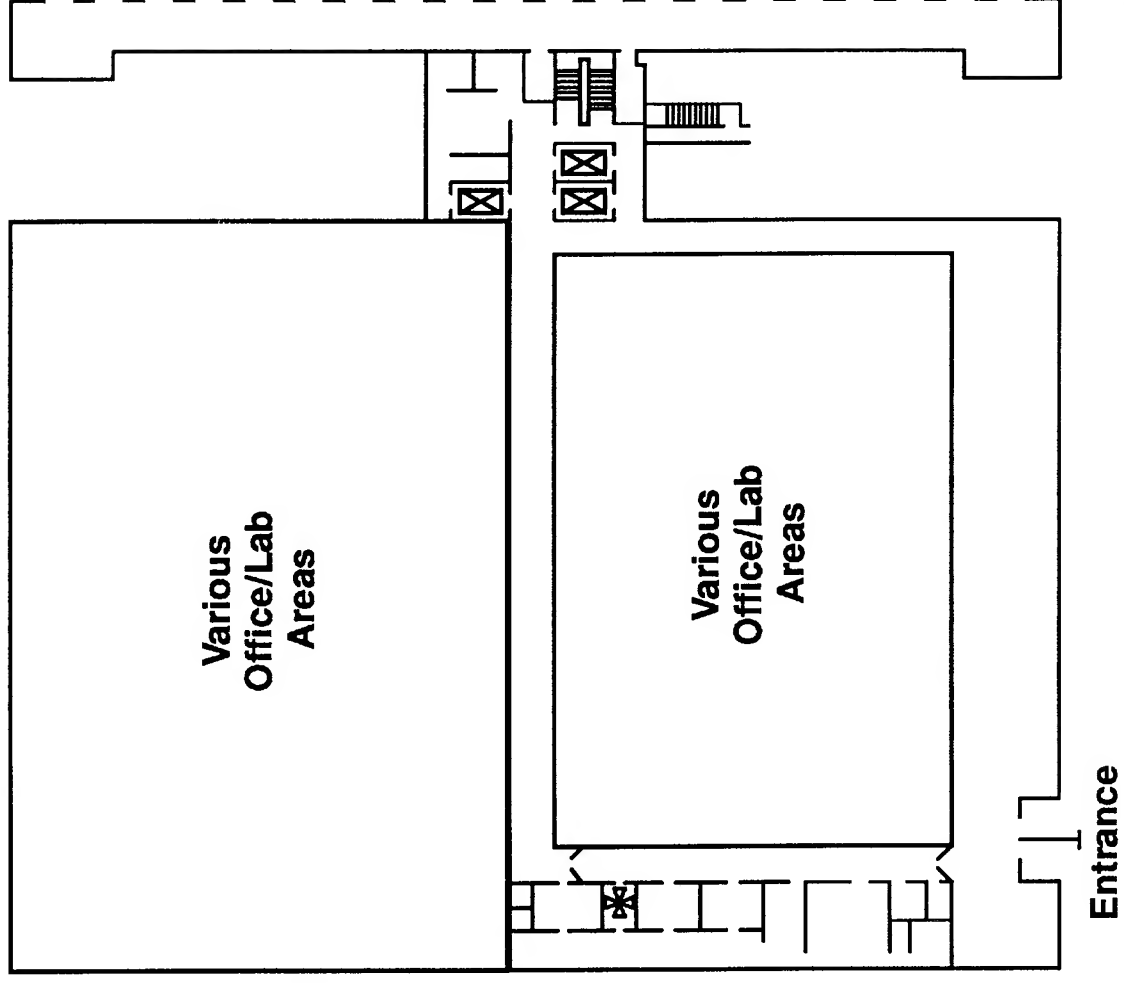
**Figure 2**  
**Emergency Room**  
**Floor Plan**

The fire originated in an isolation room approximately 150 feet from the emergency room entrance along the north-south corridor. Access to the 8 X 10-foot room was gained not only from the public corridor side but also from a nurses' (medical staff) area. The nurses' area was positioned parallel to the public corridor with several observation rooms sandwiched between the areas. This arrangement enabled the medical staff to move along a rear corridor and into treatment rooms for care. The medical area contained medical treatment materials and supplies stored in wooden cabinets or placed on counter space.

Fire damage to the emergency room area was extensive. The fire consumed most of the combustibles in the room of origin and spread to several adjacent observation rooms, also causing extensive damage. Since the doors to the room of fire origin were open, the medical area and the exit corridor also were severely damaged. The north-south corridor had extensive damage along its entire length, as did approximately half of the east-west corridor. Closed smoke doors at the north end on the north-south corridor were effective in preventing fire spread in this direction. Combustibles in the corridor area (mostly mattresses on stretchers totally

Smoke spread in the emergency room area followed a path similar to the fire spread. However, there was some smoke spread into adjacent functional areas, most likely around doors that were closed and by way of HVAC systems open ducts. Smoke was able to move freely through over 400 feet of the exit corridor to the elevator lobby because a smoke barrier door (adjacent to the room of origin) was blocked open. Other smoke barrier doors in the area were closed and were effective.
